## Technical Memorandum

SUBJECT: Capital Reinvestment in Urban Drainage Infrastructure – 2013 and Beyond  
Basis for the Development of a Comprehensive Drainage Improvement Plan

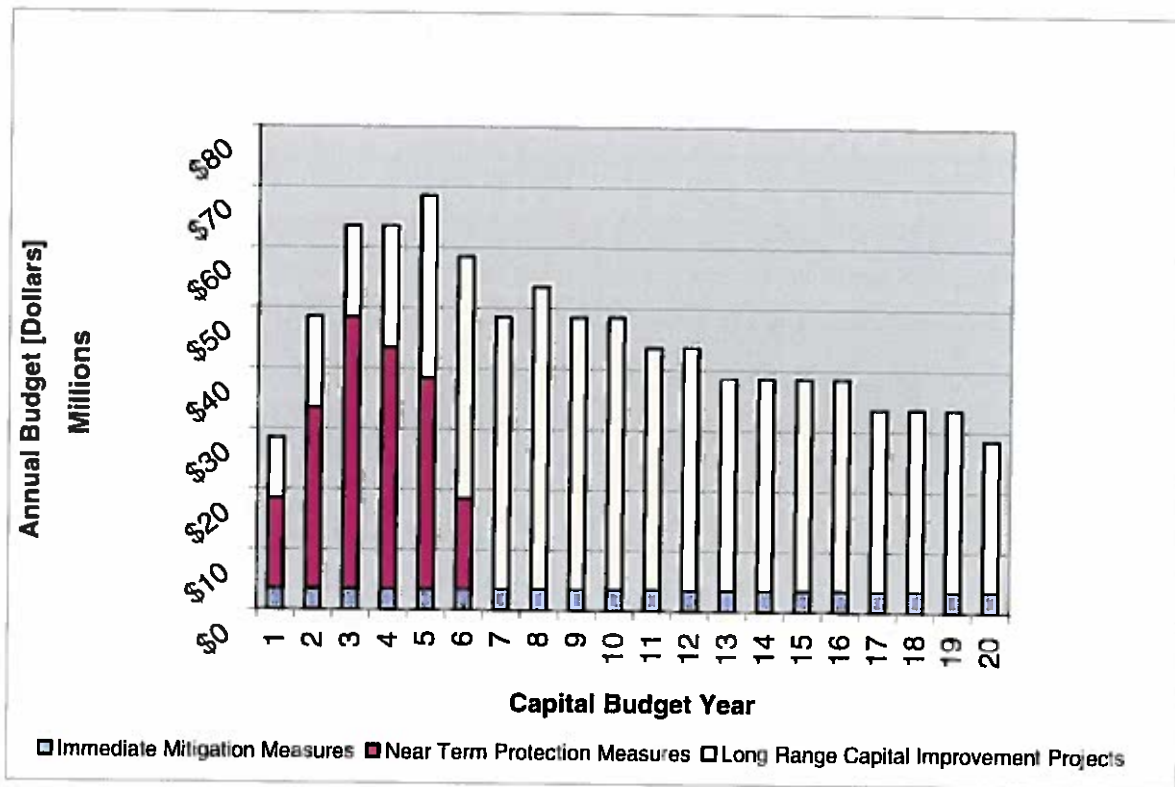
CITY OF JACKSON COMPREHENSIVE DRAINAGE IMPROVEMENT PLAN  
 FORCASTED FUNDING NEEDS  
 2013-2033

Chester Engineers has projected the citywide, long term capital reinvestment needs for the urban drainage infrastructure is \$995M over the next twenty years (Refer to Figure 4-1). As previously noted, initially the focus will be those areas scoring above an agreed *BRE* threshold value indicating a highest priority for resolution (i.e., “worst comes first”) when determining the long term capital planning needs for the drainage infrastructure. The implementation priority of the identified drainage improvement projects will be reflective of DPW budget constraints and available funding mechanisms to support a multi-year capital improvement plan. Further input from DPW personnel is required to determine the existing budget constraints in order to complete this evaluation.

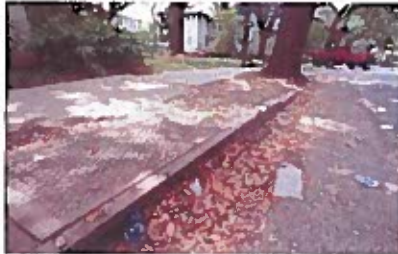
- ❖ Establishment of a ***Clean Sweep Jackson*** public campaign to enlist resident is keeping seasonal lawn debris out of local gutters and catch basins. It is recommended that the City work with

Neighborhood Associations to organize a city-wide collection of trash and vegetation and other debris in residential neighborhoods which accumulate in the gutters and drainage ditches throughout the City Residents and Business Owners are requested to bag all lawn clippings and leaves for pick up by City solid-waste removal crews. It is recommended that this be held semi-annually (Early Spring and Fall) to prevent the accumulation of yard debris

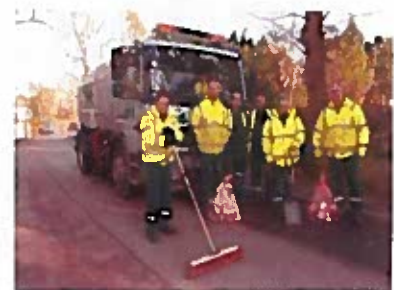
- ❖ ***Deployment of Street Cleaning Contracts*** to enhance the frequency with which the City Streets and Gutters are cleaned. A windshield survey of the City indicated a significant portion of the city gutters are clogged with grit and leaves throughout the metropolitan area. It is recommended that the city begin an aggressive street cleaning program utilizing outside contractors to remove asphalt, grit and accumulated debris from the city streets over a six month period. The current DPW staffing levels do not allow for timely cleaning of the all the streets. Long term city-wide program should be established to systematically clean the street gutters on a semi annual basis. Routine cleaning of the streets should minimize localized flooding issues on city streets by restoring the conveyance capacity of the existing gutters. In addition routine street cleaning will prevent roadway grit and debris from increasing sediment accumulation in both the conveyance piping network and conveyance channels which will reduce the required frequency of channel dredging in the future. An ancillary benefit would be improved water quality in the local streams and creeks as the contaminants would no longer make there way into the receiving streams.

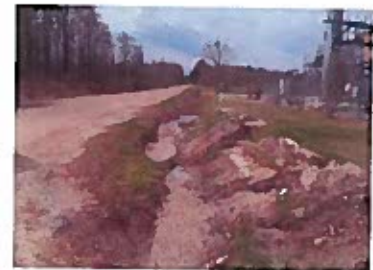
- ❖ **Removal of Vegetation and Debris from Drainage Ditches**  
These maintenance activities can be accomplished by the addition of two full time dedicated crews and the procurement of two trucks to the DPW to perform routine cleanout of city-wide drainage ditches. It is recommended that every drainage ditch basin be properly cleared of accumulated sediments and debris on a three year rotating basis. Current staff levels and equipment have directly impacted the DPW's ability to establish a routine cleaning schedule of the drainage ditches. With

limited staff, the DPW has been required to operate in a reactionary response mode to resident reports of clogged ditches and roadway flooding based on the 311 Call System to deploy a maintenance crew as opposed to a planned routine maintenance program.

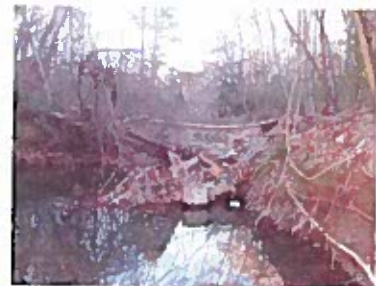
- ❖ ***Deployment of Channel and Tributary Cleaning Contracts*** - It is our understanding that routine maintenance activities have been hampered by the availability of the maintenance vehicles. Initially, the DPW should utilize existing channel and tributary cleaning contracts vehicles to deploy emergency crews to remove the 85 previously - identified channel blockages within the first six months of the capital improvement plan. Once this is completed the DPW should budget for the following:

Additional maintenance personnel, equipment and vehicles are warranted at this time. It is recommended that a minimum of two dedicated channel maintenance crews be added to the DPW staff with appropriate vehicles and equipment to remove trees, other debris and sediment in order to clear blockages in conveyance channels that have resulted from years of sedimentation, fallen trees, utility crossing and illegal dumping of white goods within the conveyance area of the drainage channels. In order to ensure adequate channel conveyance capacity these blockages must be removed, the channel typical sections should be surveyed to determine and monitor the current system conveyance capacity and quantify the amount of the sedimentation buildup.

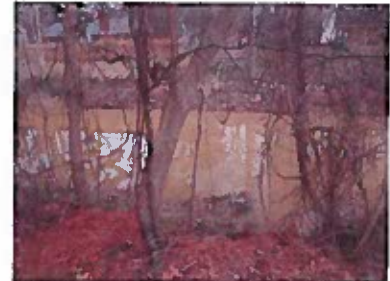
Many neighborhoods areas experiencing floods are likely due to clogged inlets and storm drains and low points in street grades which cause ponding of runoff and nuisance flows in yards and driveways. However, the local storm drainage system must discharge into the major drainage channels. These major channels must have adequate capacity to convey the collected runoff downstream without causing backup in the local storm drains. Therefore, a combination of significant major drainage channel improvements, monitoring and routine maintenance programs is necessary to address the flooding issues at the local level. It is recommended that the remaining 79 miles of major channel as well as major drainage tributaries also be investigated.

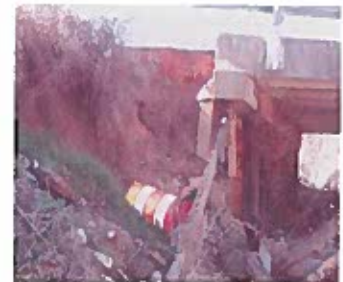
***Identify and Repair Compromised Channel Crossings*** – Initial field survey investigation crews identified compromised channel crossings. A city map illustrating the extent of the site verification investigation areas completed to date can be found in Appendix 2. The detailed findings of these field investigations including drainage channel exhibits indicating photograph locations, representative photographs and field observation notes were presented in our previous Technical Memorandum provided in January 2013.

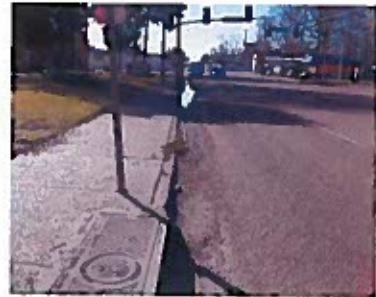
- ❖ Spot Repair [Cold Mill and Overlay Streets] to provide an adequate edge of pavement elevation to match the existing catch basin openings.
- ❖ Re-construct grades of Selective Streets to facilitate storm water runoff flowing into drainage structures and ditches.

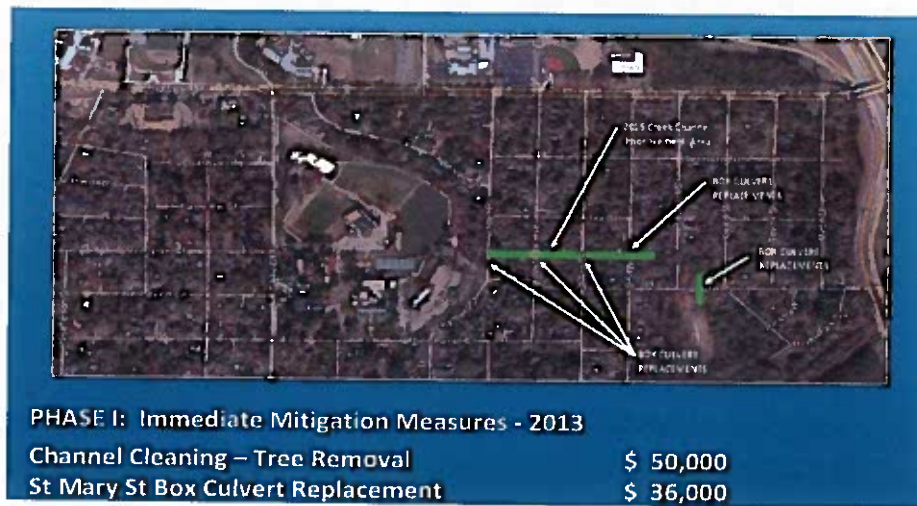
FIGURE 5 - 2  
BELHAVEN CREEK – PHASE 1 IDENTIFIED IMMEDIATE MITIGATION MEASURES  
N. STATE ST/WOODROW WILSON/ST MARY ST/ PIEDMONT ST/BELMONT ST/ LAUREL ST

Based on field observations the following project has been identified as a typical mitigation measure within the Belhaven Creek basin. Details of the budgetary cost estimated and estimated quantities can be found in Appendix 8 of this memorandum.

Given the limited nature of our field investigations, absence of detailed survey and detailed hydraulic analysis, further investigation of repetitive area flooding within the basin, establishment of flow monitoring and a hydraulic model of the Belhaven Creek Drainage Basin is warranted prior to making further recommendations for specific immediate mitigation measure recommendations. It is recommended that the City proceed immediately with street cleaning and catch basin cleanout maintenance programs in these neighborhoods immediately to lessen the severity and occurrence of localized flooding in the area until at which time specific capacity improvement recommendations can be recommended.

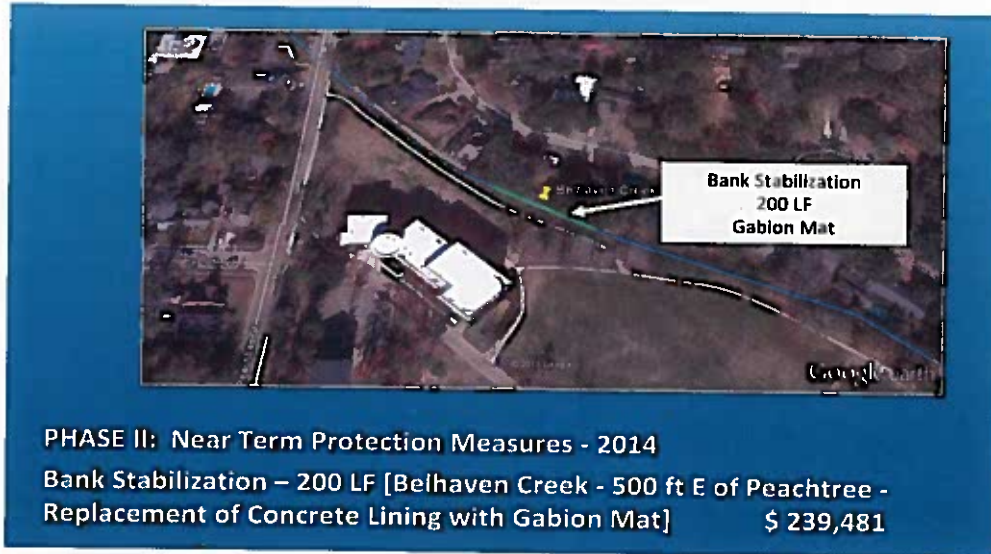
FIGURE 5 - 3  
 BELHAVEN CREEK – NEAR TERM PROTECTION MEASURES  
 PEACHTREE ST - EAST AND WEST CHANNEL BANK STABILIZATION

Based on field observations the following project has been identified as a typical mitigation measure within the Belhaven Creek basin. Details of the budgetary cost estimated and estimated quantities can be found in Appendix 8 of this memorandum.

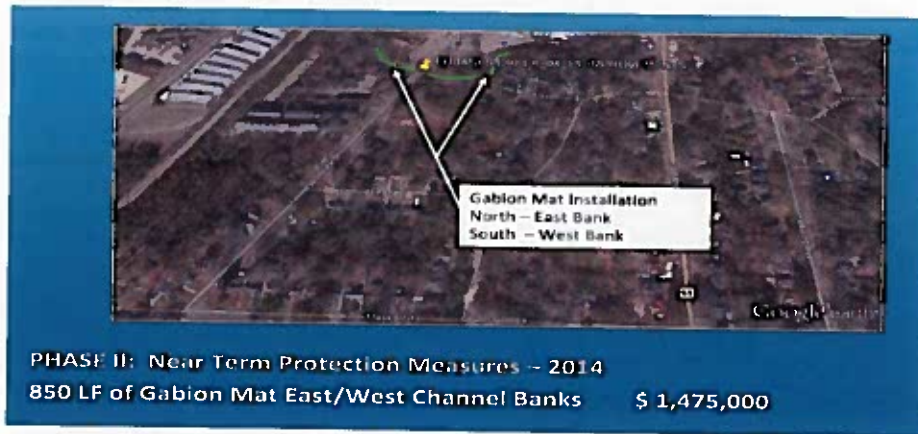
FIGURE 6 - 2  
EUBANKS CREEK –NEAR TERM PROTECTION MEASURES  
NORTHVIEW DRIVE BRIDGE – BANK STABILIZATION

As stated earlier 4 areas of bank failures were identified during field investigations. It is recommended that in the near term approximately 850 linear feet of channel bank near the Northview Drive Bridge be stabilized with gabion mat to stabilize the northeast and southwest banks after this section of channel has been cleared of debris.

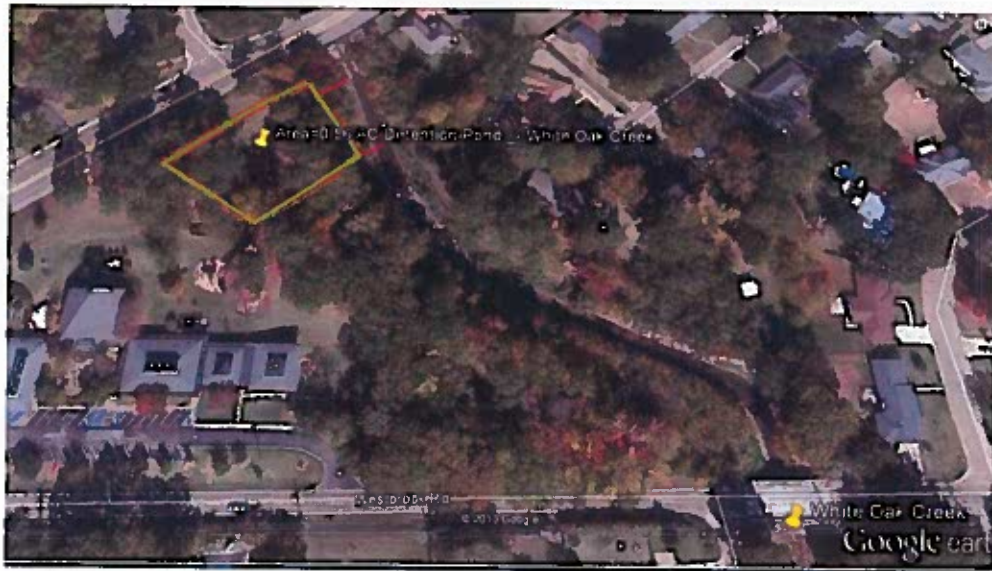
**FIGURE 10 – 3**  
**WHITE OAK CREEK BASIN IMMEDIATE MITIGATION MEASURES**  
**OLD CANTON ROAD STORM WATER DETENTION/ATTENUATION POND**

Neighborhood street flooding field investigations identified the need for and a possible location for a 0.6 acre Stormwater detention/attenuation pond to reduce the severity of flash flooding during 100 year storm events prior to the creation of long term channel improvements. It is proposed that the storm water detention pond be located adjacent to White Oak Creek in the vicinity Old Canton Road. The capital cost of the project is currently estimated at \$ 120,000.
